**Provision of Independent Environmental Checking
Service for Investigation, Review and Design of
First Stage of Tseung Kwan O Desalination Plant**

Detailed Design Plan for Slope Mitigation Works

DETAILED DESIGN PLAN FOR SLOPE MITIGATION WORKS

First Stage of Desalination Plant at

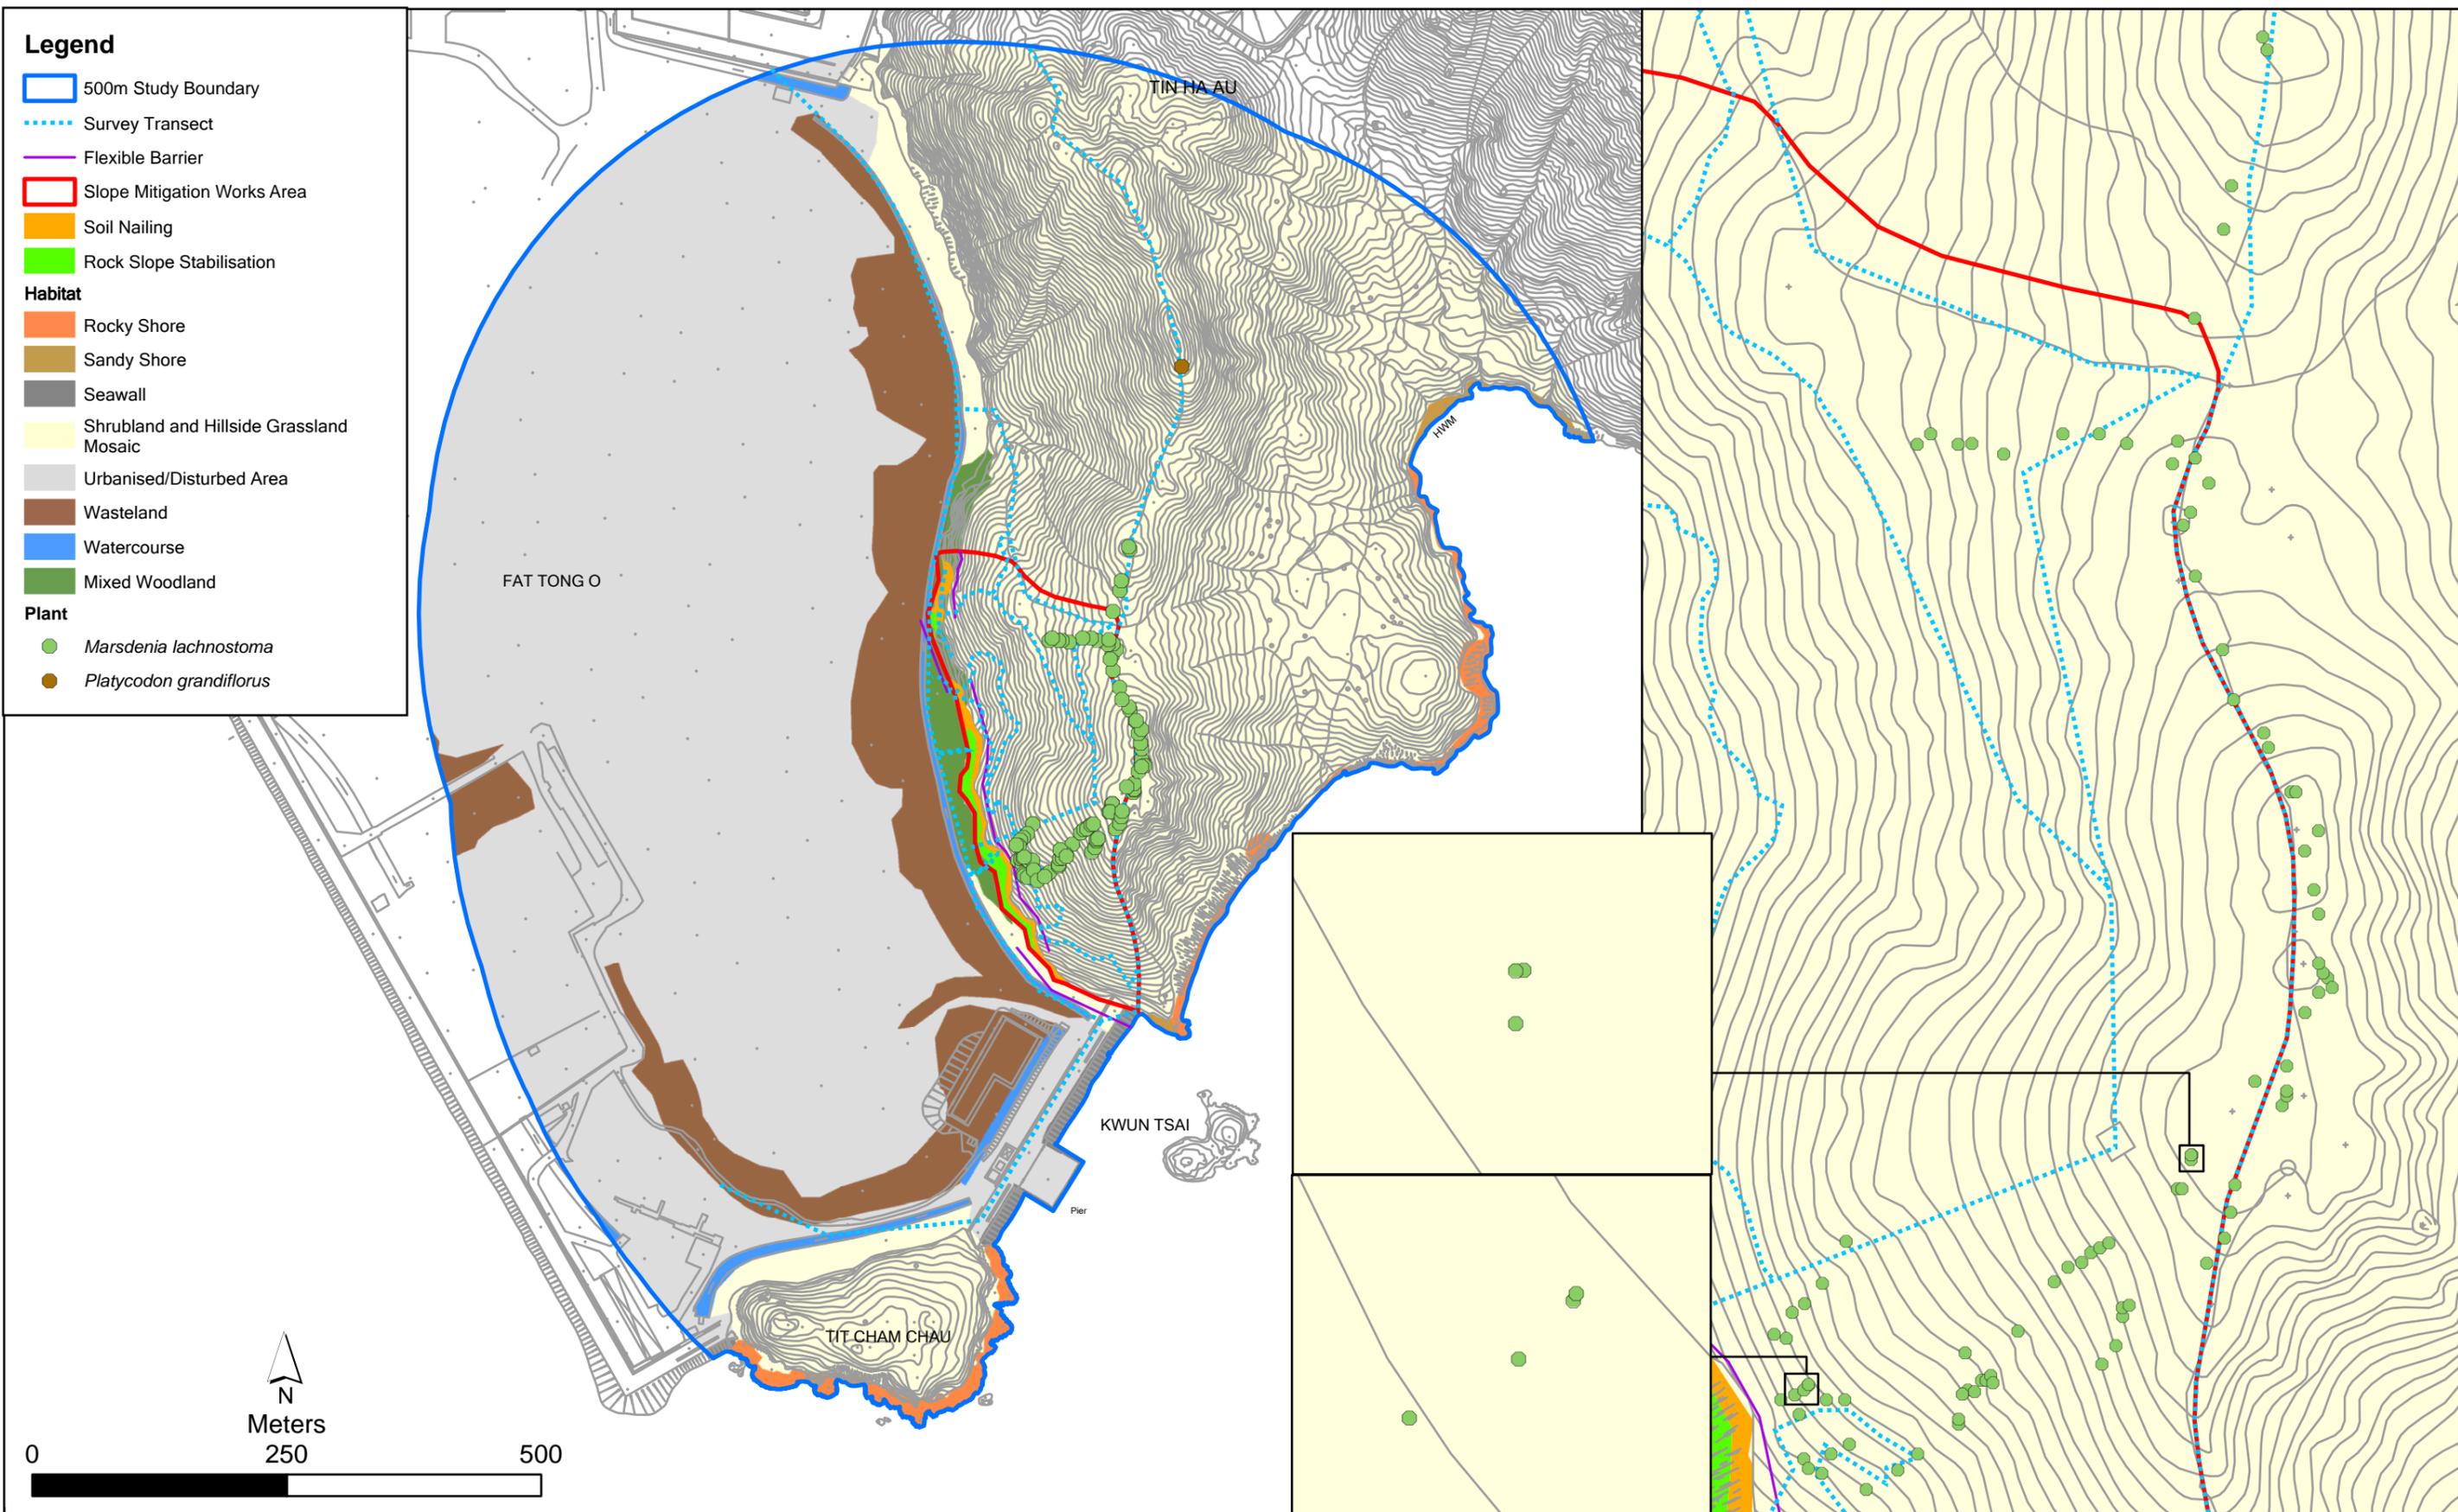
Figure 3.2

Study Area for Updated Vegetation Survey - Species of Conservation Importance (Original Slope Mitigation Works)

- 2.4.4 It was noted that species of conservation importance were identified within or were in close proximity to the proposed flexible barriers and soil nails in the Country Park, as indicated in Appendix E.

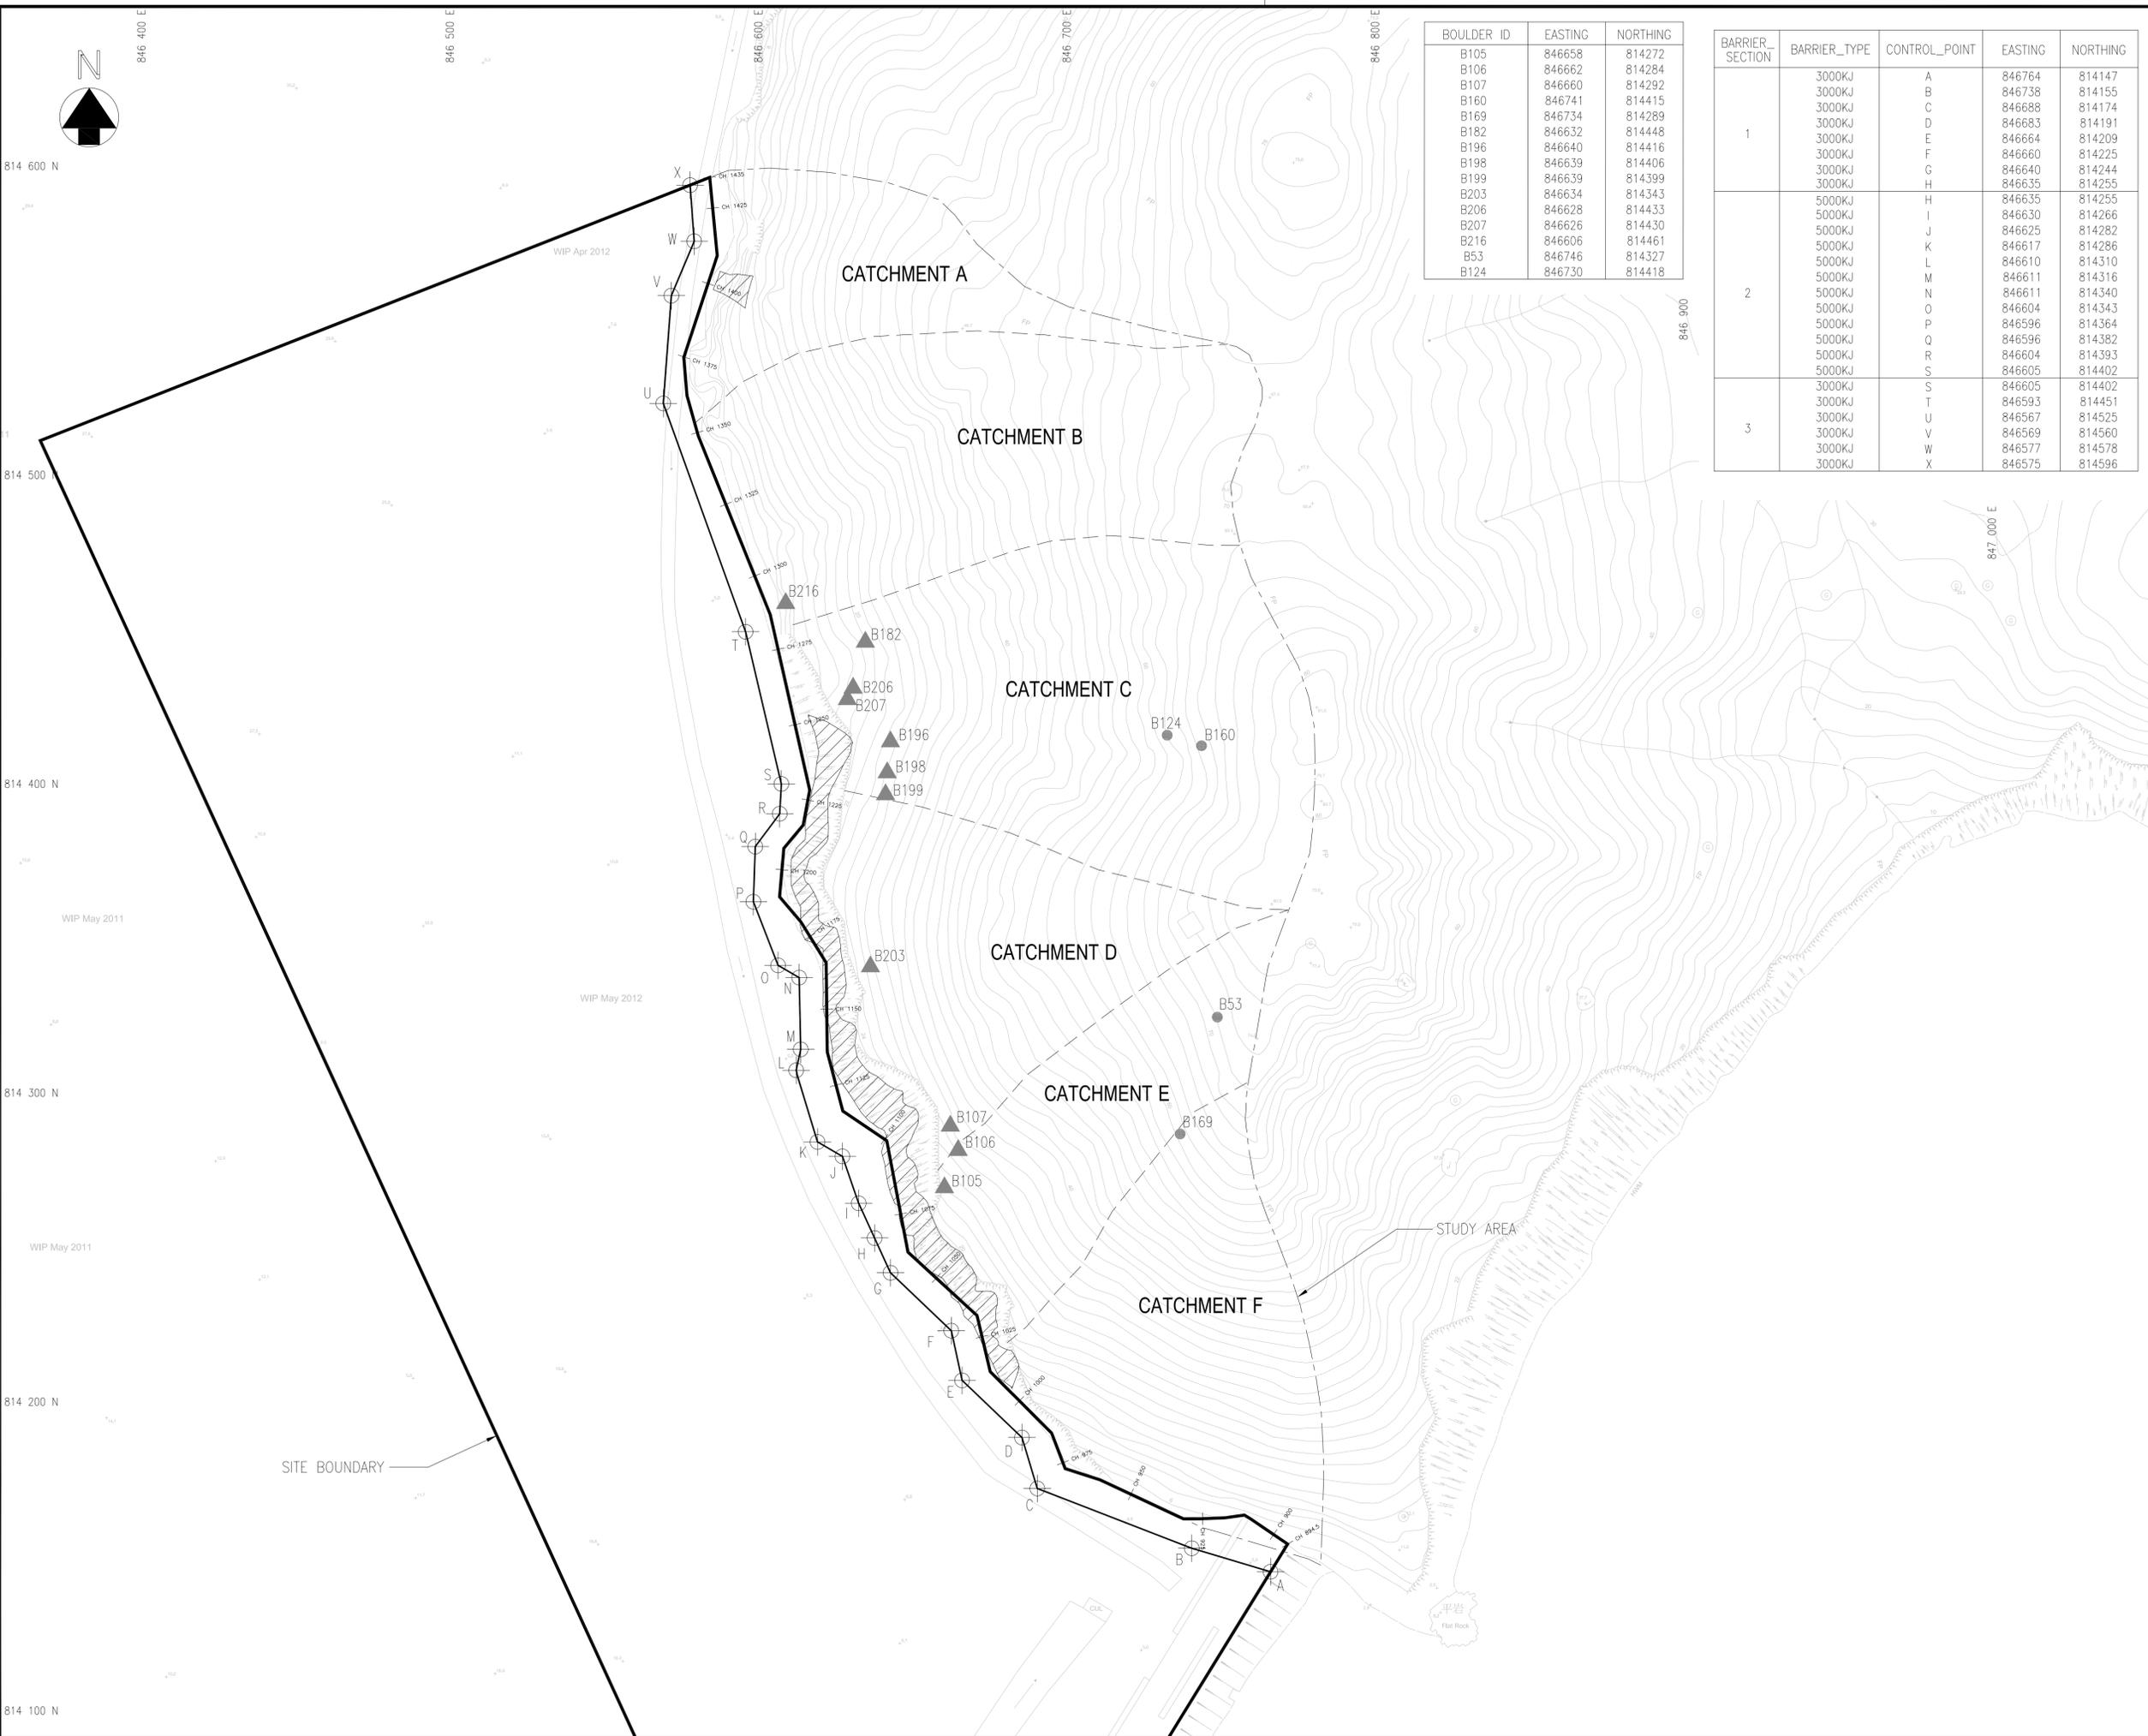
- NOTES:**
- EXTENTS OF WORKS AS SHOWN ARE TENTATIVE ONLY.
  - THIS DRAWING SHALL BE READ IN CONJUNCTION WITH DRAWING NO. 190495/B/DD/00-20001 TO 20011, 30001 TO 30004.
  - SETTING OUT COORDINATES ARE BASED ON HK GRID REFERENCE.
  - SETTING-OUT POINTS OF FLEXIBLE BARRIER ARE TENTATIVE. DIMENSIONS OF LENGTH, SEPARATION AND OVERLAP OF THE FLEXIBLE BARRIER SECTIONS SHALL BE SUBJECT TO THE MANUFACTURER'S RECOMMENDATION.

- LEGEND:**
- PROPOSED BOULDER TO BE IN-SITU BROKEN OFF INTO PIECES WITH ALL DIMENSIONS LESS THAN 1m AND DEPOSITED IN STABLE CONDITION
  - ▲ PROPOSED BOULDER TO BE REMOVED
  - ▨ PROPOSED ROCK SLOPE IMPROVEMENT/STABILISATION WORKS (REFER TO DRG. NO. 190495/B/DD/00-20001 TO 20011)
  - PROPOSED 4m HIGH FLEXIBLE BARRIER

- 190495/B/DD/00-10001 gives the layout plan of slope mitigation works
- 190495/B/DD/00-20001 to 20011 gives the locations of rock slope works
- 190495/B/DD/00-30001 gives the notes of slope mitigation works including the recommended good site practices and mitigation measures inside Country Park
- 190495/B/DD/00-30002 to 30003 gives the details of rock slope works
- 190495/B/DD/00-30004 gives the reference details of flexible barrier

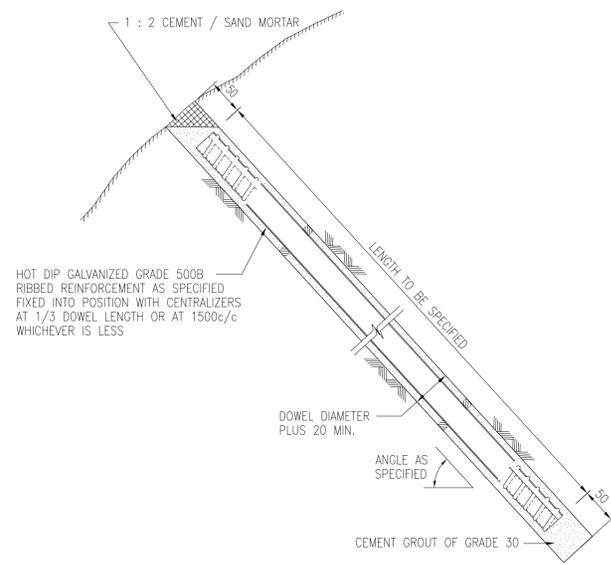
1. EXACT LOCATIONS, ANGLES AND LENGTHS OF ROCK DOWELS SHALL BE DETERMINED ON SITE BY THE SUPERVISING OFFICER.

TYPICAL ARRANGEMENT OF ROCK DOWEL

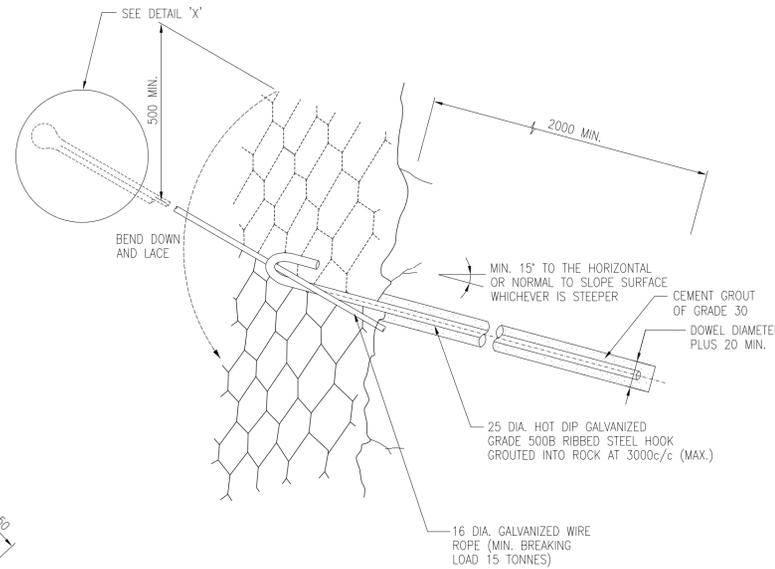
FIXING WIRE MESH AT TOP OF ROCK FACE

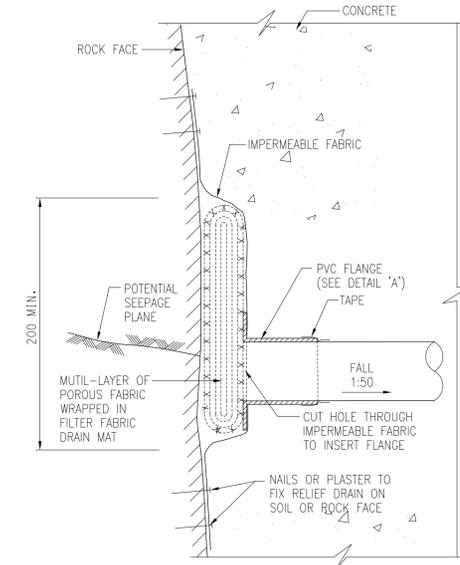
RELIEF DRAIN DETAIL

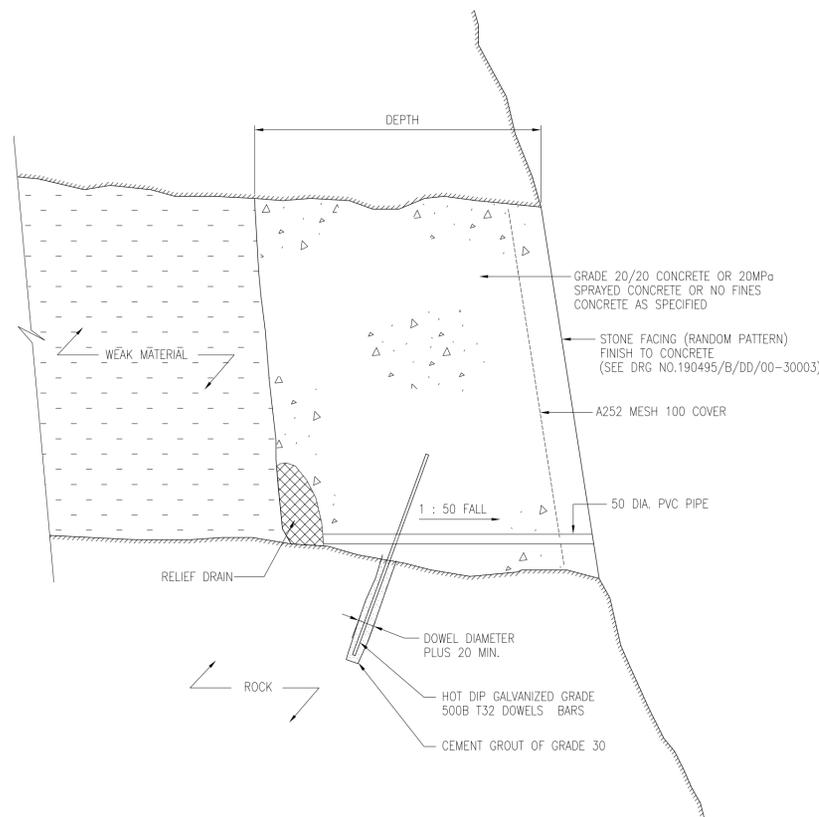
TYPICAL ROCK FACE DENTITION

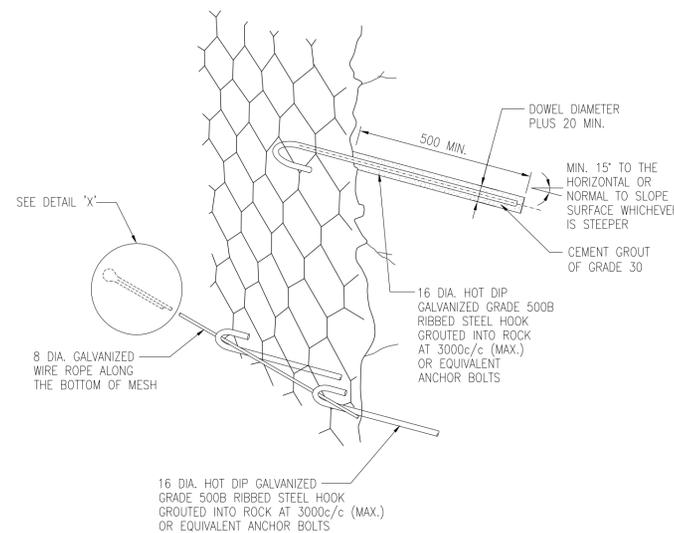
FIXING WIRE MESH TO ROCK FACE AND AT BOTTOM OF ROCK FACE

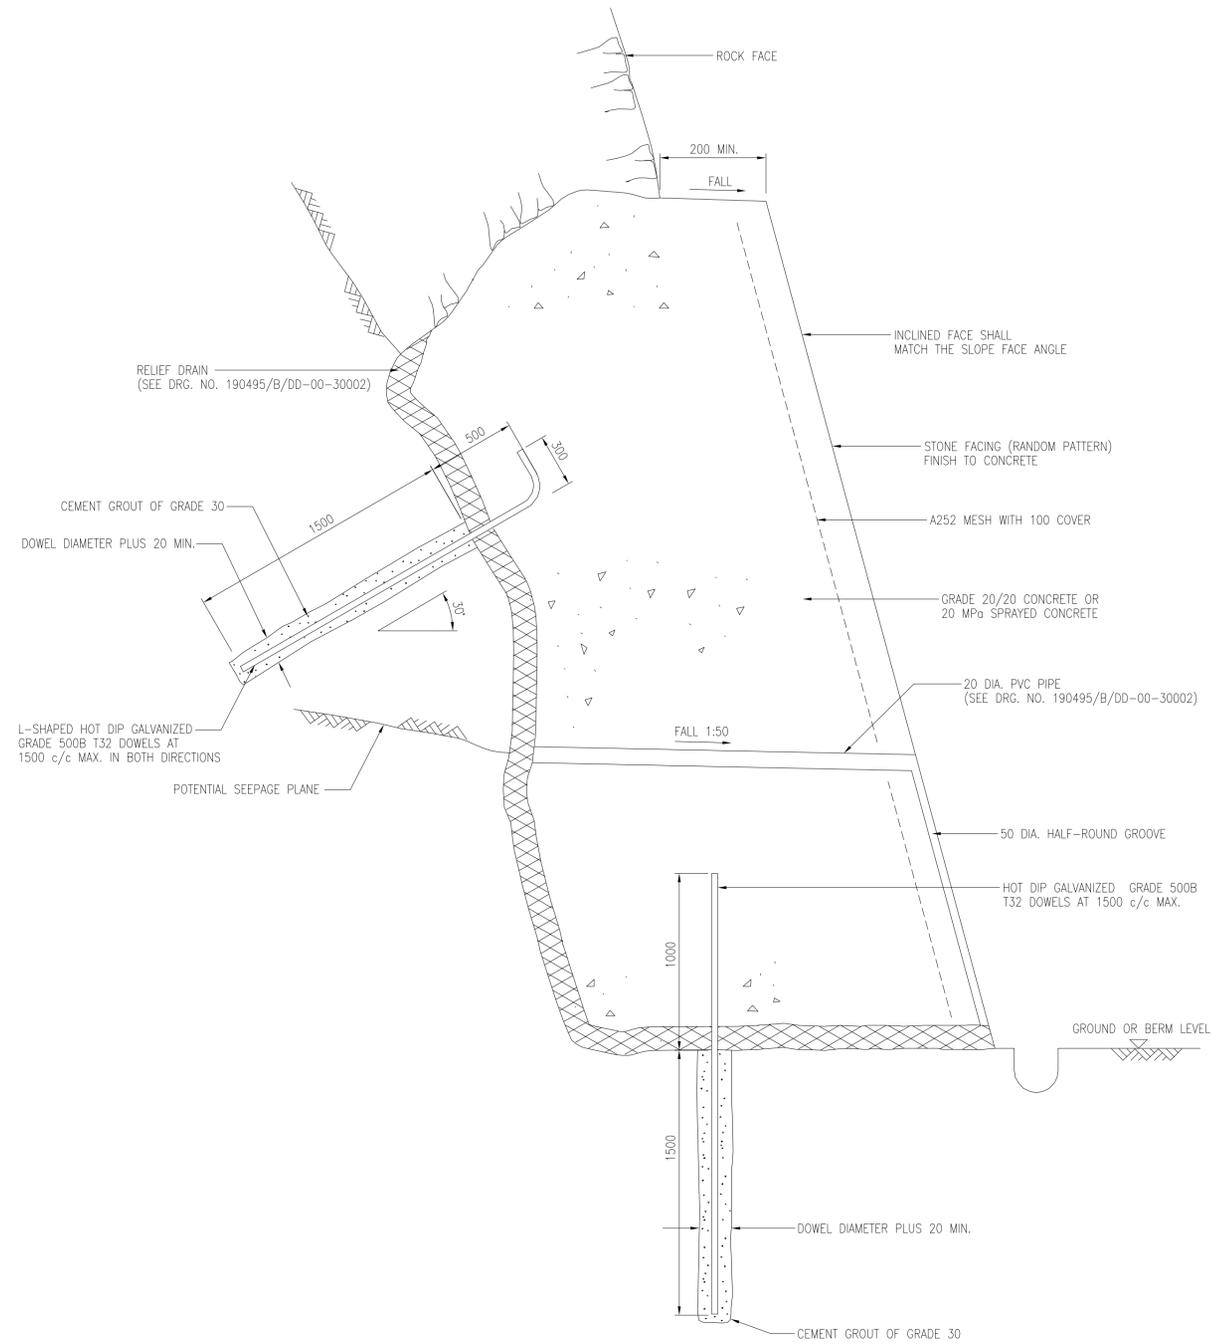
TYPICAL DETAILS OF CONCRETE BUTTRISS

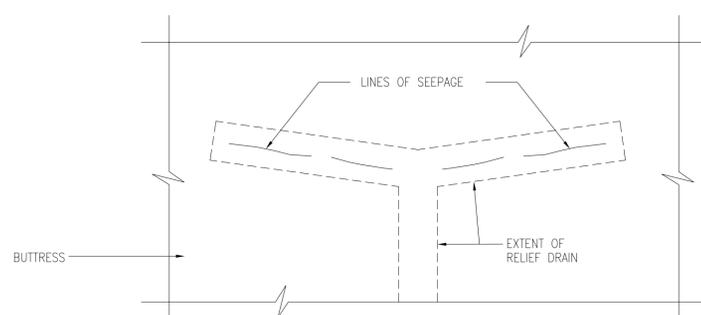
TYPICAL ELEVATION OF RELIEF DRAIN

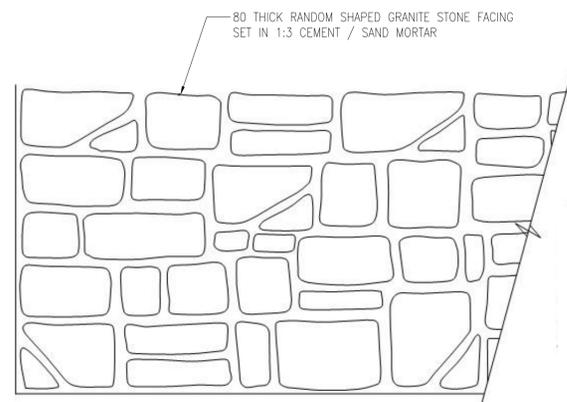
ELEVATION OF STONE FACING (RANDOM PATTERN)

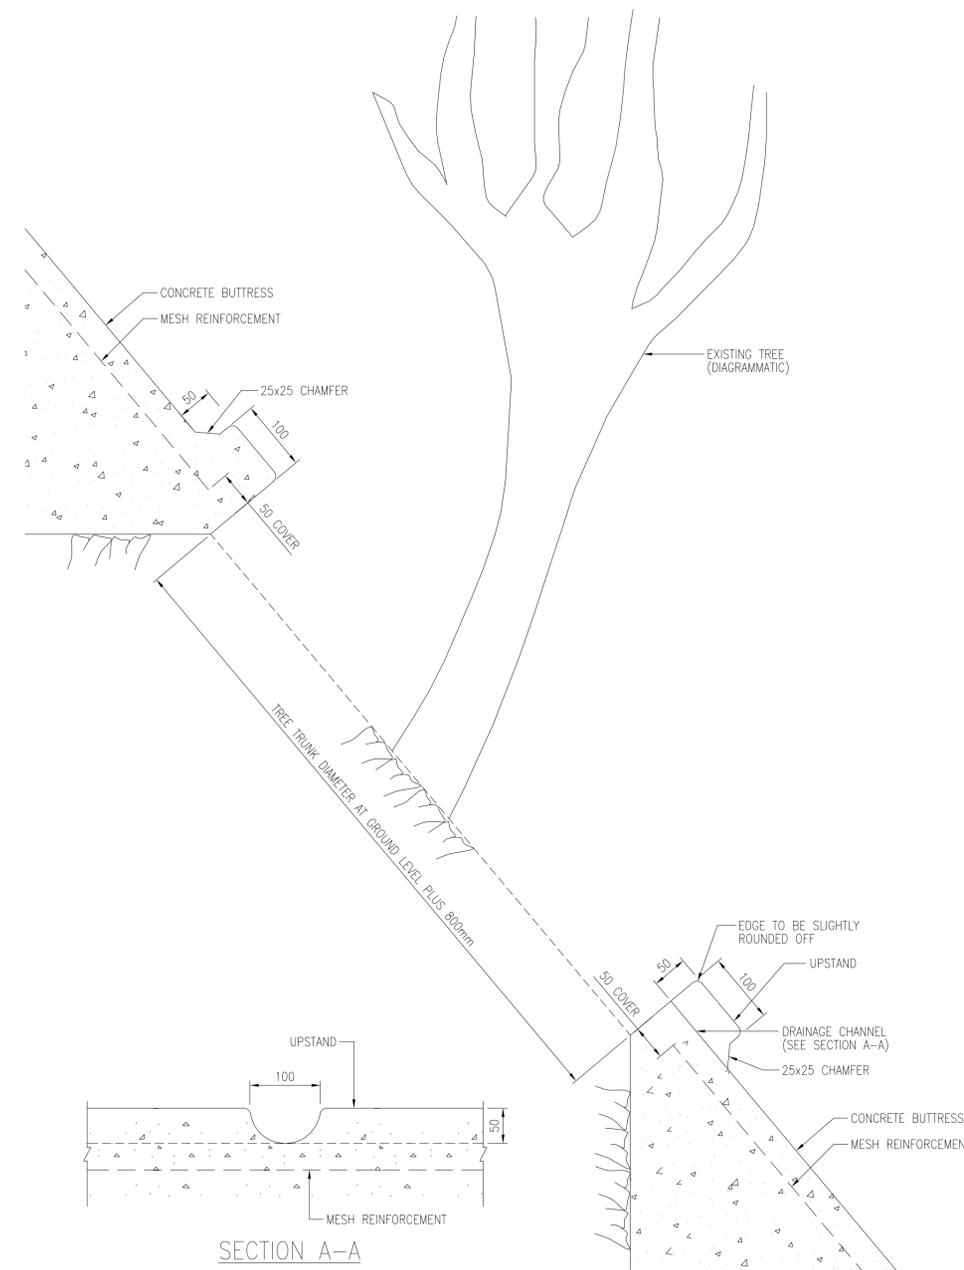
SECTION A-A

SECTION OF TREE RING

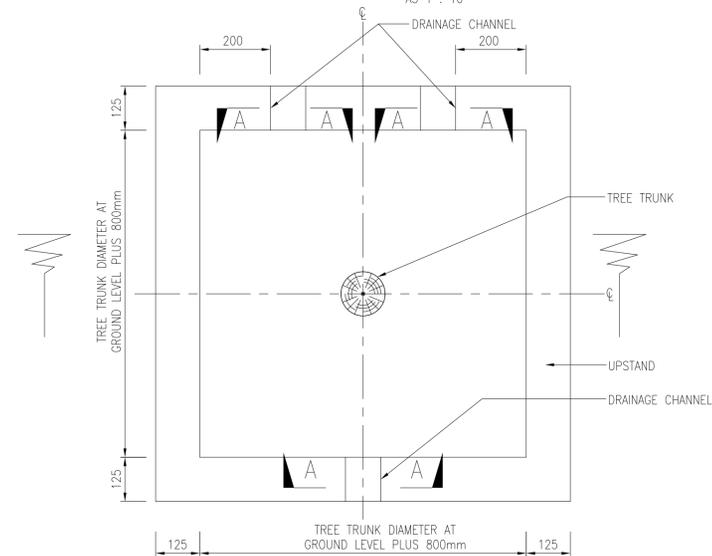
PLAN OF TREE RING

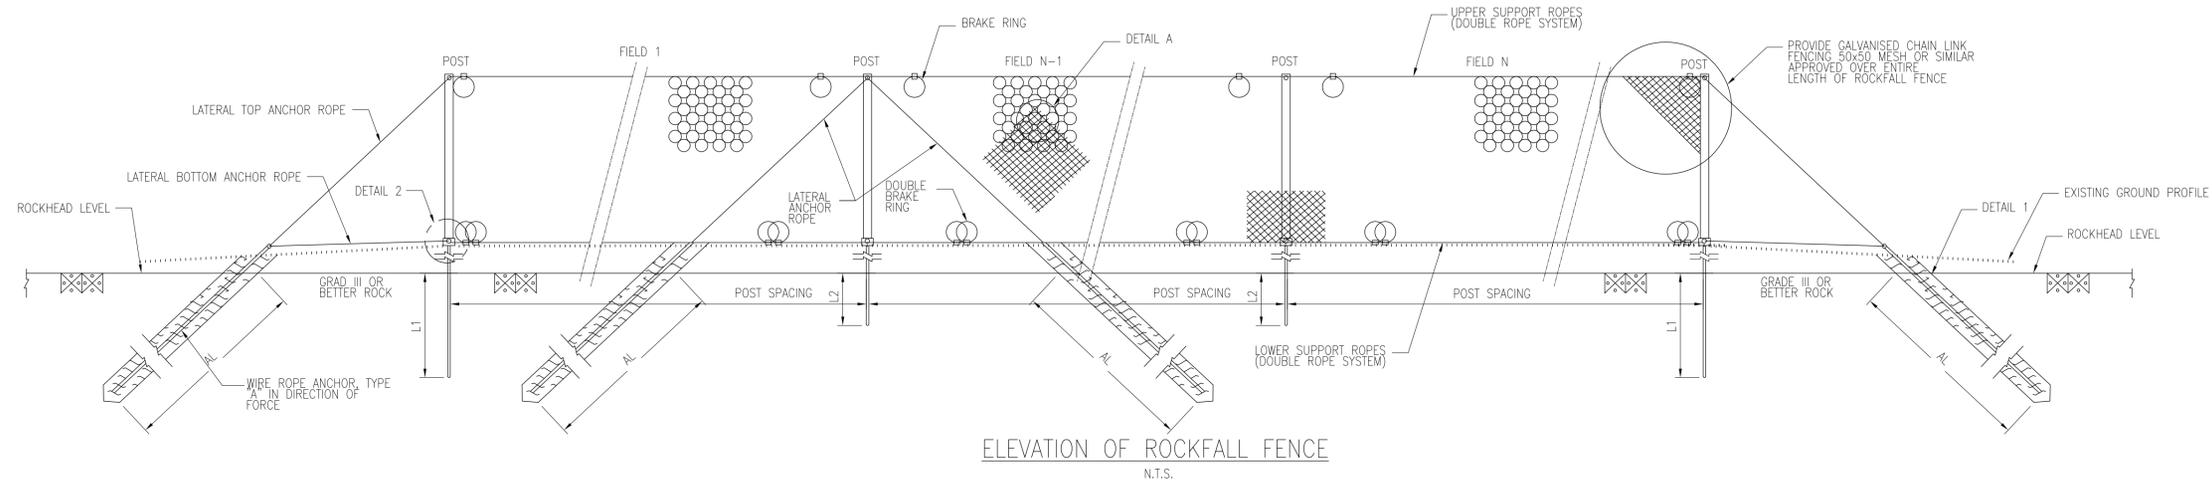
ELEVATION OF ROCKFALL FENCE  
N.T.S.

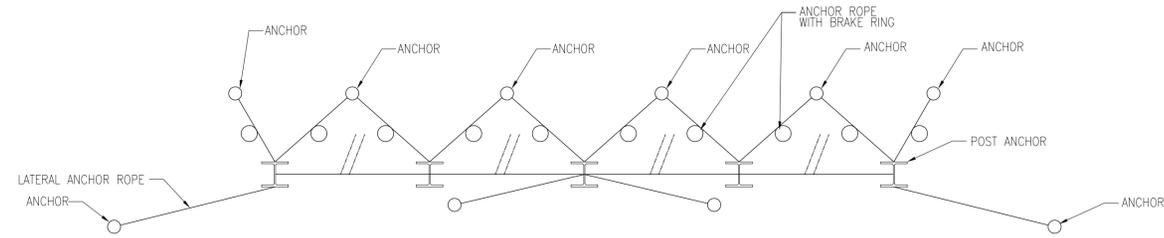
LAYOUT OF ANCHOR POINTS  
N.T.S.

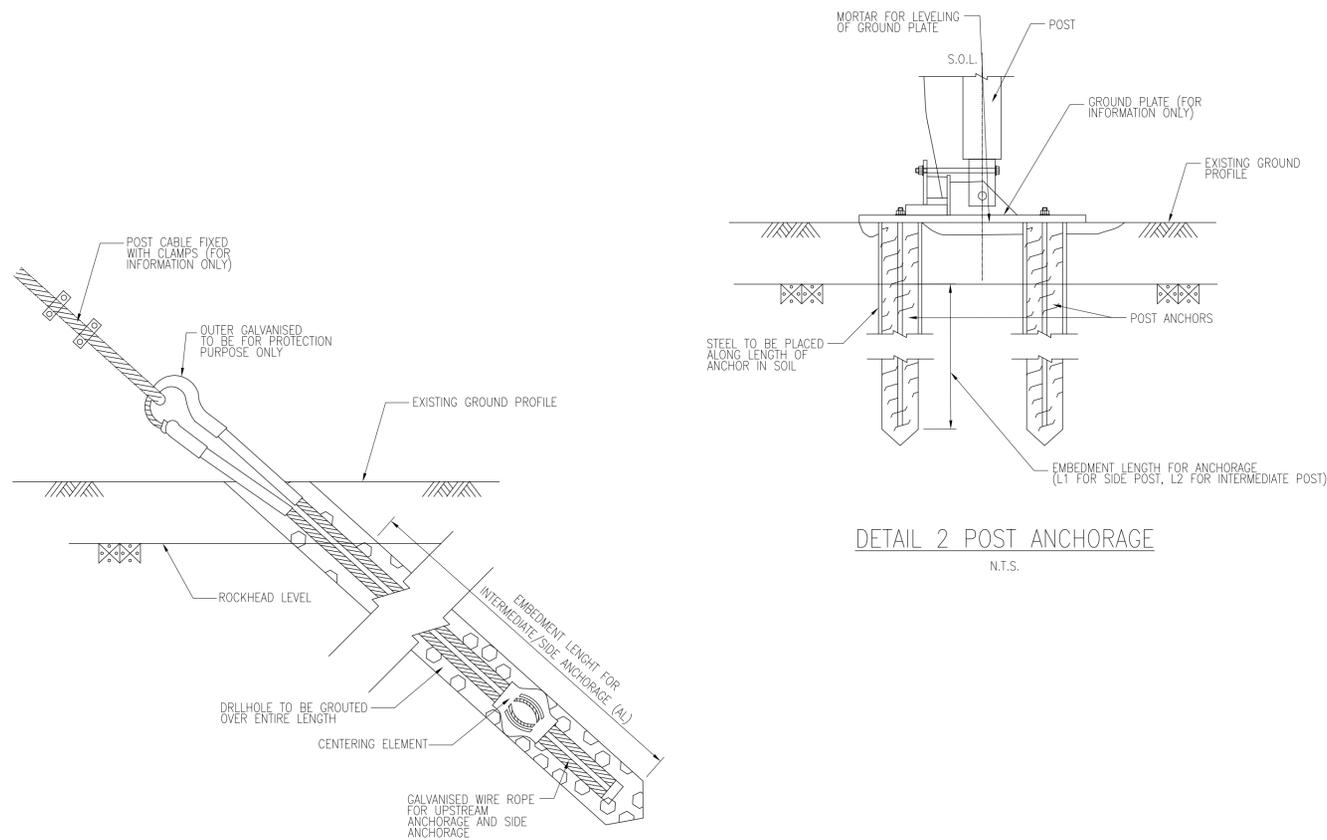
DETAIL 1 WIRE ROPE ANCHORAGE  
N.T.S.

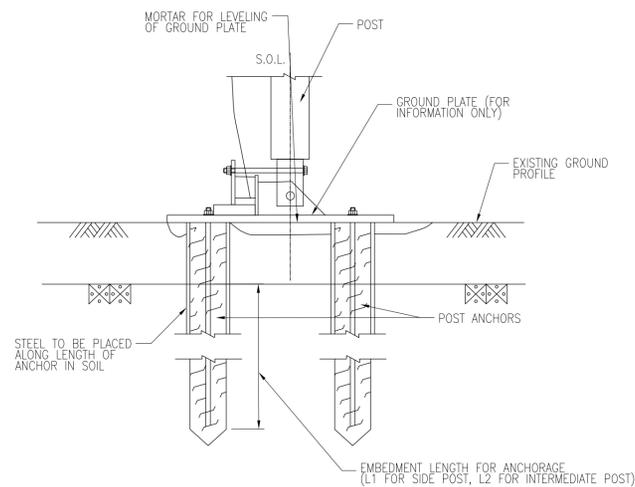
DETAIL 2 POST ANCHORAGE  
N.T.S.

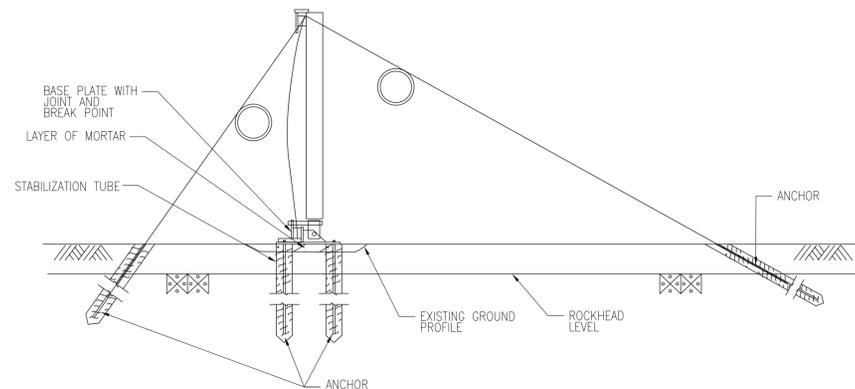
ANCHORING TYPE "A"  
N.T.S.

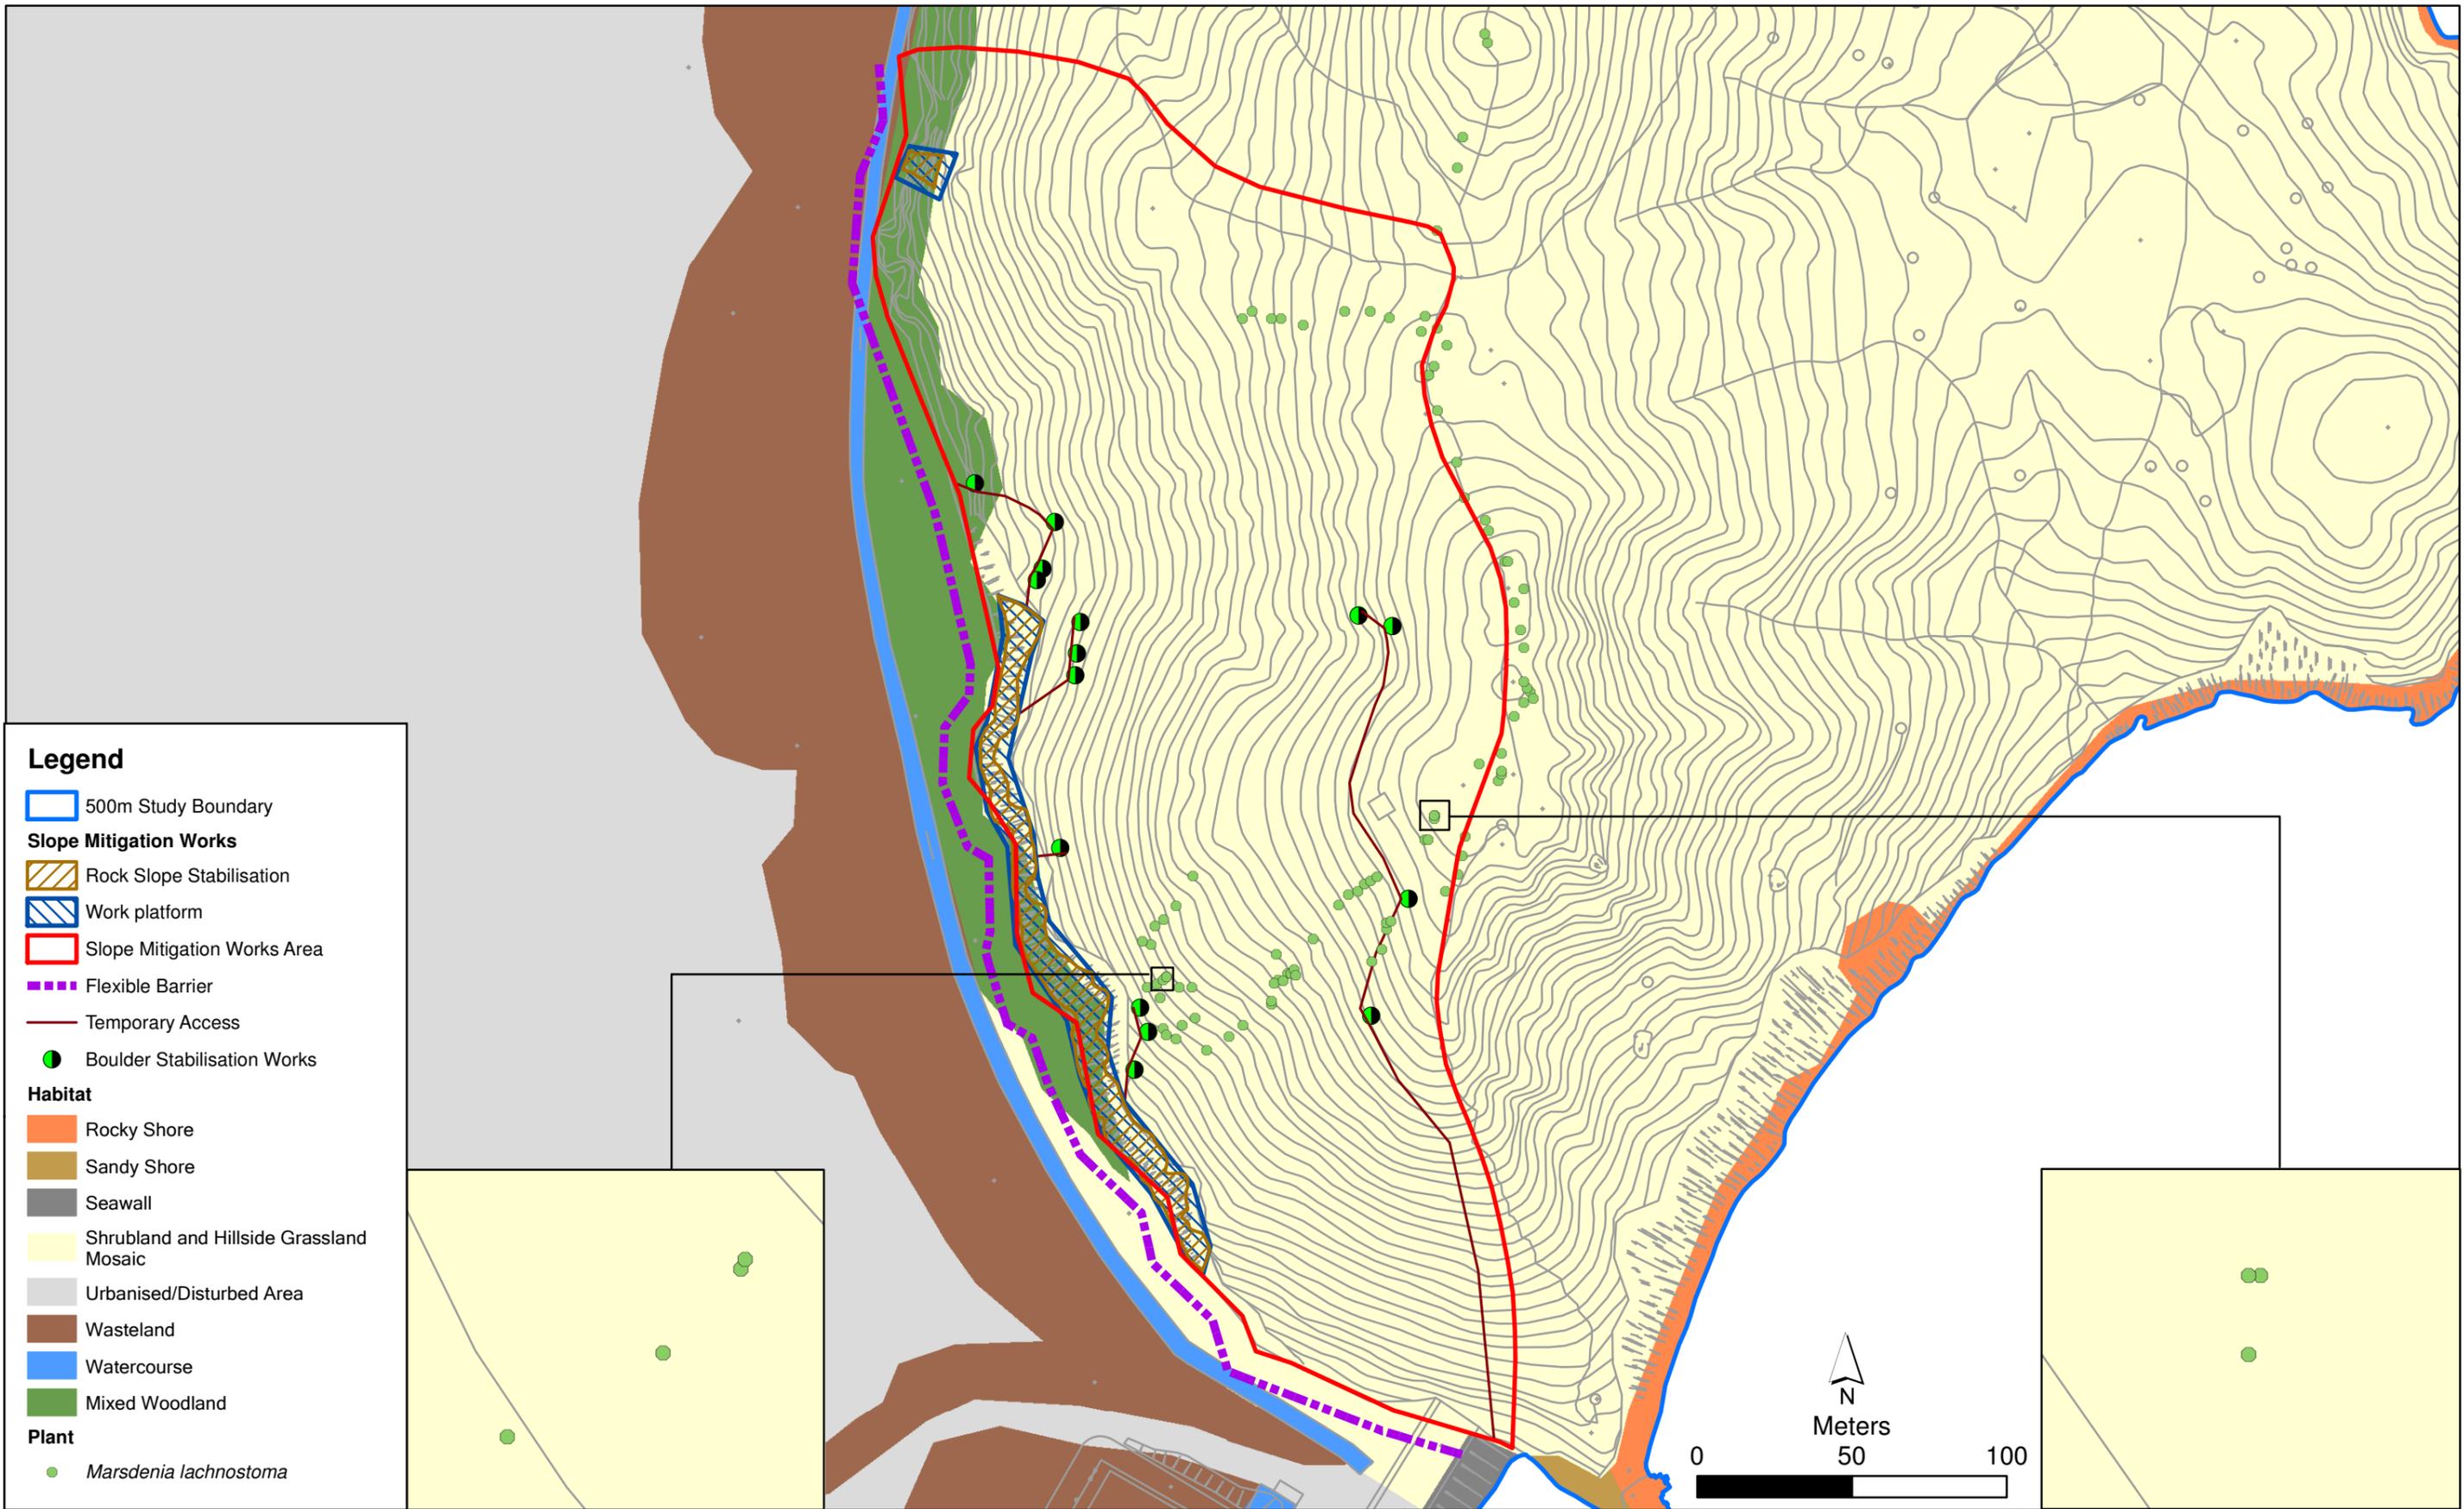
Appendix G

Species of Conservation Importance in the Revised Scheme of Slope Mitigation Works and Recommended Temporary Access and Working Platform
