Contract No. 13/WSD/17

**Design, Build and Operate First Stage of Tseung Kwan O
Desalination Plant**

**Quarterly EM&A Report No.10
(Period from 1 June to 31 August 2022)**

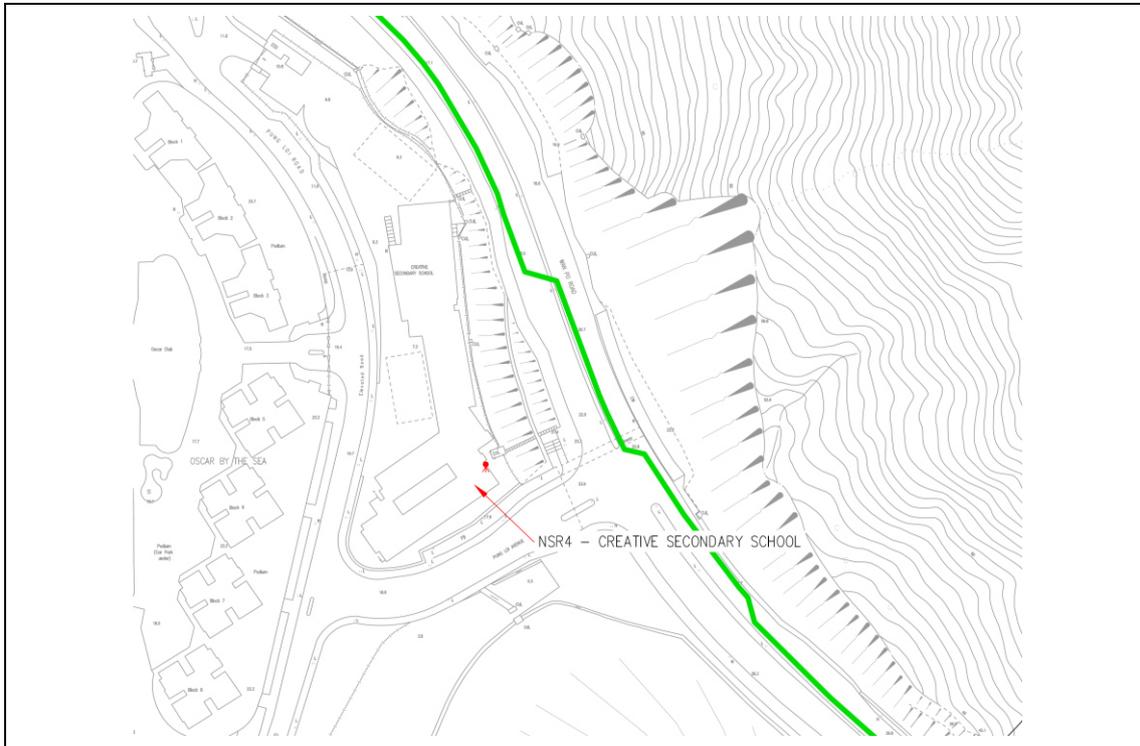
Figure 2.1 NSR4 Creative Secondary School

The monitoring locations should normally be made at a point 1m from the exterior of the NSRs building façade and be at a position 1.2m above the ground. A correction of +3dB(A) should be made to the free-field measurements. Three noise monitoring locations for impact monitoring at the nearby sensitive receivers are shown in **Figure 2.1-2.3**.

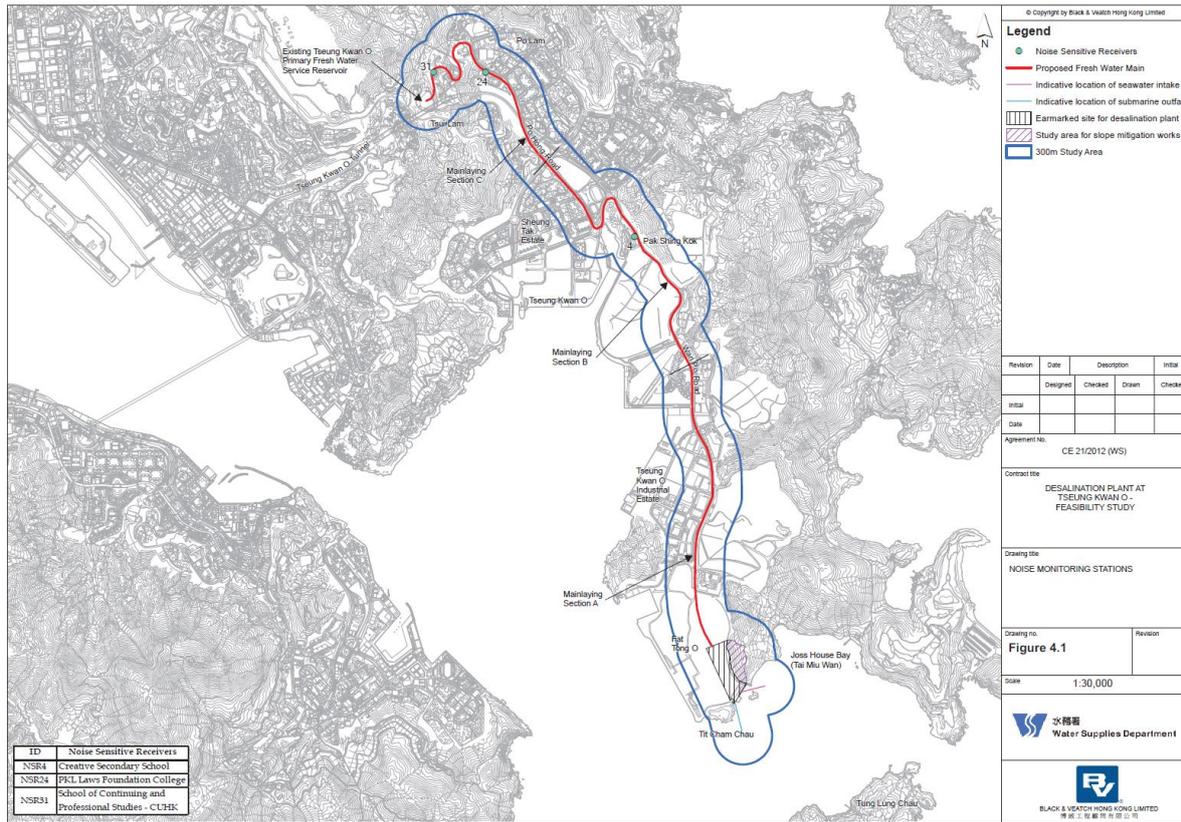
Figure 2.4 Site Layout Plan with Noise Sensitive Receivers and Desalination Plant

Referring to EM&A manual Section 4.1.2, the impact noise monitoring should be carried out when there are project-related construction activities undertaken within a radius of 300m from the monitoring stations. No noise monitoring station was located within a radius of 300m of the Project site as shown in **Figure 2.4**, no impact monitoring for noise impact was conducted in the reporting period.

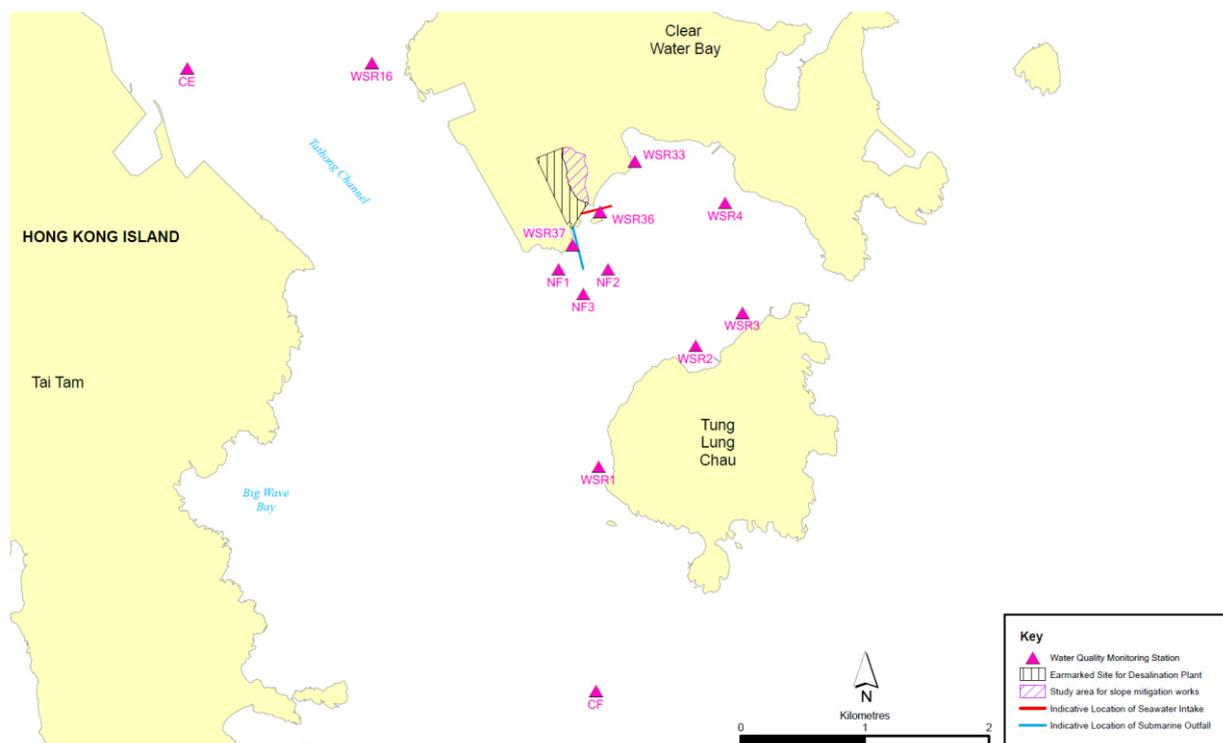
Figure 3.1 Impact Water Quality Monitoring Locations under EM&A Manual

| Station | Easting | Northing | Description |
|---|---|---|---|
| NF2 | 846942 | 813614 | Edge of mixing zone, ~ 200m east of outfall diffuser |
| NF3 | 846742 | 813414 | Edge of mixing zone, ~ 200m south of outfall diffuser |

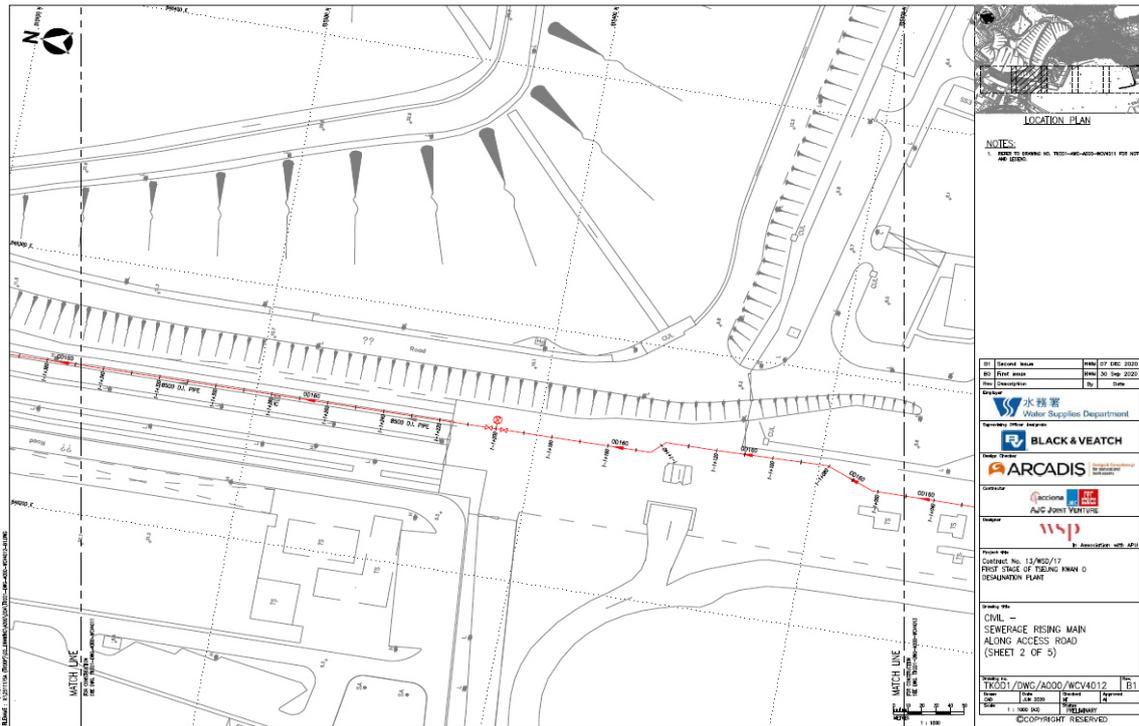
Figure 5.1 Location Map for Landfill Gas Monitoring at Wan Po Road

In this reporting period, 104 times of landfill gas monitoring were recorded at Wan Po Road (Ch1+513 – Ch1+625). No exceedance of action and limit levels for methane, oxygen and carbon dioxide was observed. Monitoring was conducted during excavations at 1m depth or more within the consultation zone and whenever workers entered the excavation on the day.
