## Contract No. 13/WSD/17

## Design, Build and Operate First Stage of Tseung Kwan O Desalination Plant

## Monthly EM&A Report No.29 (Period from 1 June to 31 July 2022)

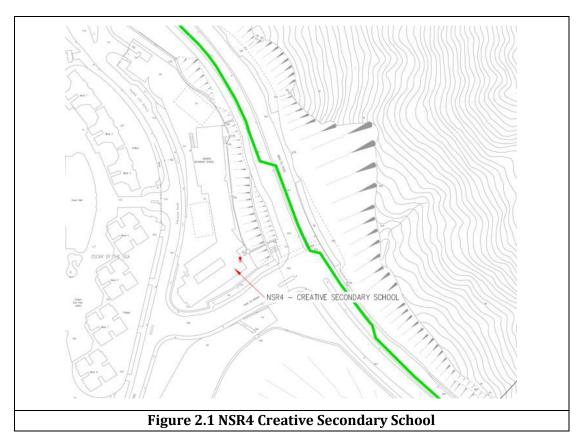
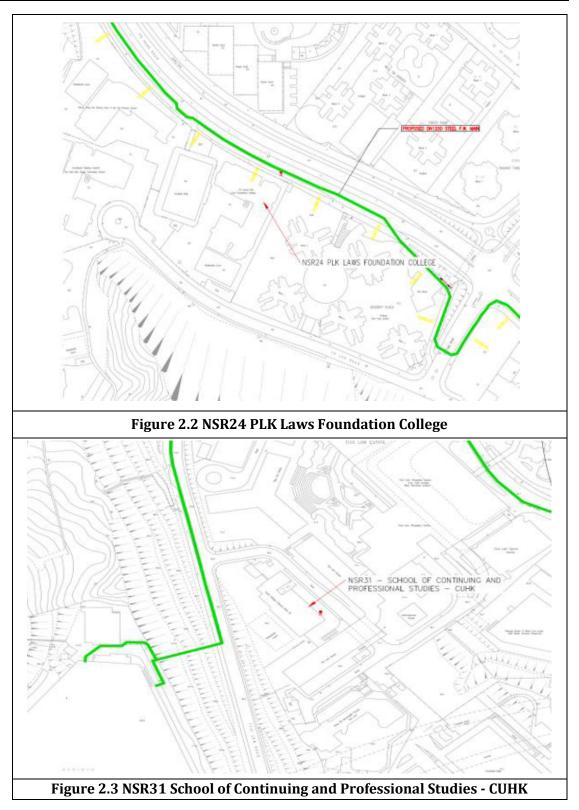
2.9. Three noise monitoring locations for impact monitoring at the nearby sensitive receivers are shown in **Figure 2.1-2.3**.

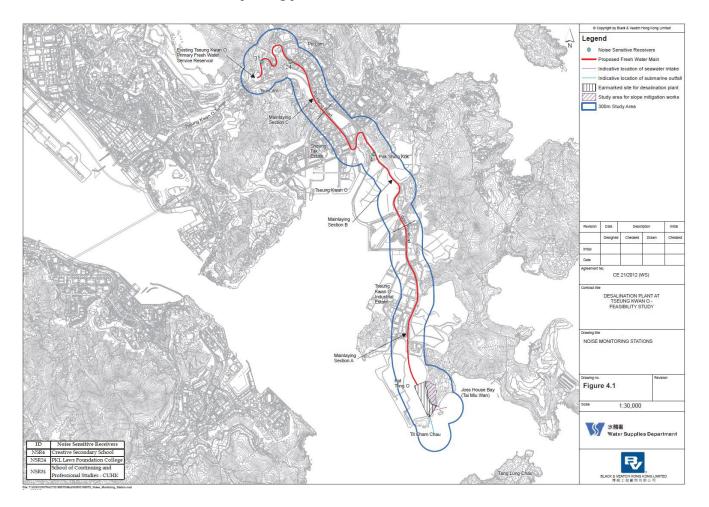
Figure 2.4 Site Layout Plan with Noise Sensitive Receivers and Desalination Plan

2.14. Referring to EM&A Manual Section 4.1.2, the impact noise monitoring should be carried out when there are Contract-related construction activities undertaken within a radius of 300m from the monitoring stations. No monitoring station was located within a radius of 300m of the Contract site as shown in **Figure 2.4**, no impact monitoring for noise impact was conducted in the reporting period.

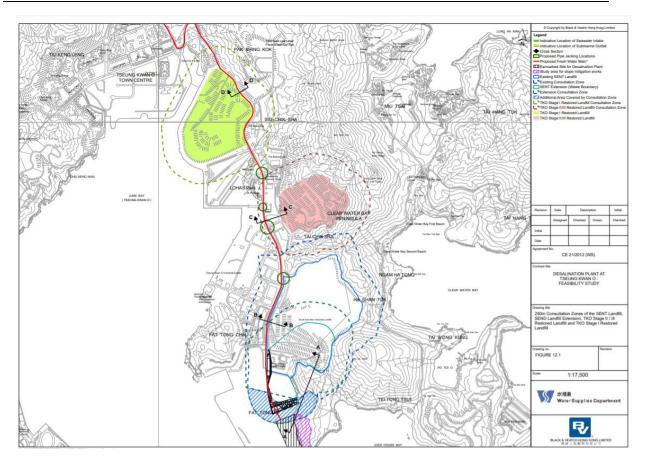
Figure 5.1 Overview of the SENT Extension Consultation Zone and the Contract Site Area

5.5. Since part of the desalination plant (Wan Po Road and MIC compound/Basketball Court) and the indicative area of natural slope mitigation works fall within the SENT Landfill Extension Consultation Zone in this contract (Figure 5.1), landfill gas monitoring would be required for Wan Po Road and MIC compound/Basketball Court (Figure 5.2) if excavations were conducted at more than 300mm deep. Although SENT Landfill Extension has commenced operation since November 2021, no excavation works were conducted at MIC compound/Basketball Court. Hence no landfill gas monitoring would be scheduled for MIC compound/Basketball Court at the current stage.

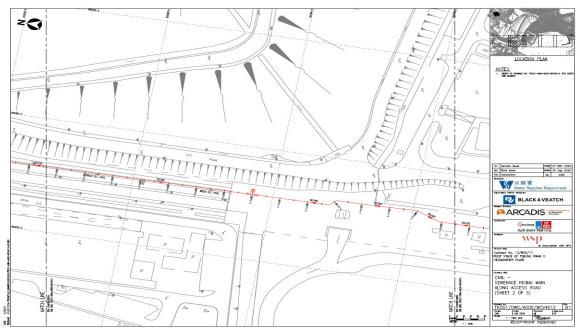
Figure 5.2Location Map for Landfill Gas Monitoring at Wan Po Road

5.6. The area required to be monitored for landfill gas in the reporting period is shown in **Figure 5.2**.

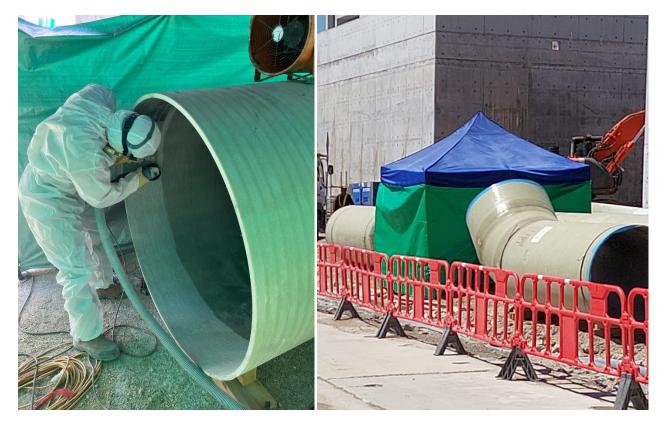
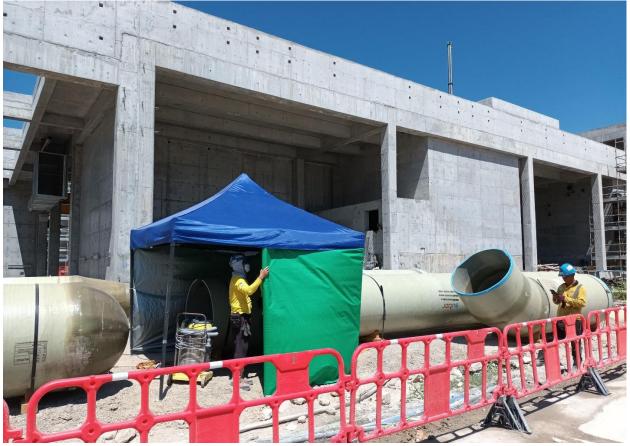
Air Quality: Glass Reinforced Plastics (GRP) pipe cutting and grinding works was carried out inside the sheltered area and vacuum cleaning device was used to minimize dust emission

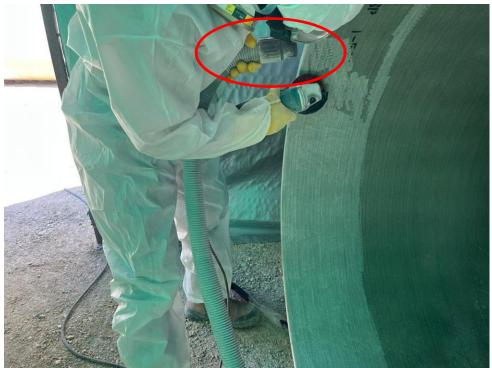
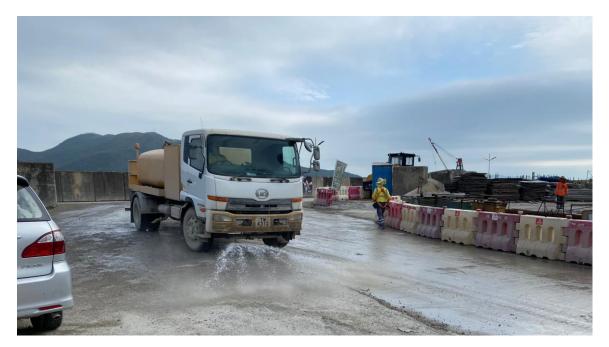
Dust suspension measure observed during regular site inspection

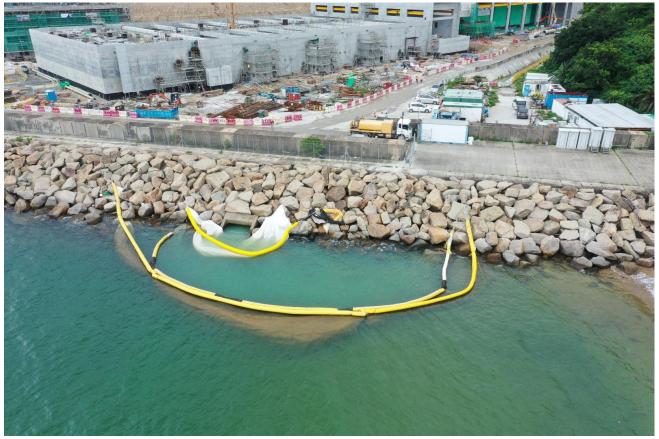
Water Quality: Three layers of silt curtain at the inland water outfall was properly erected

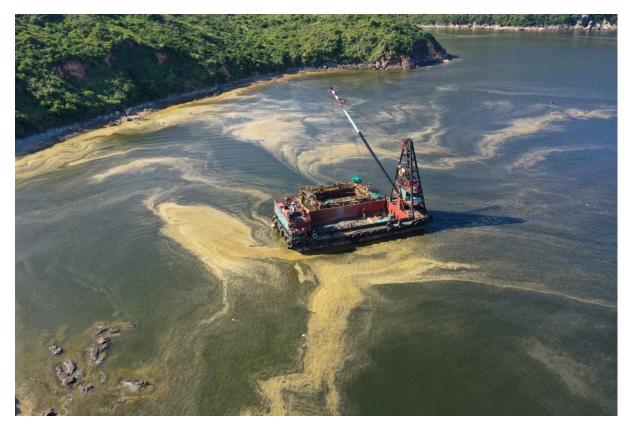
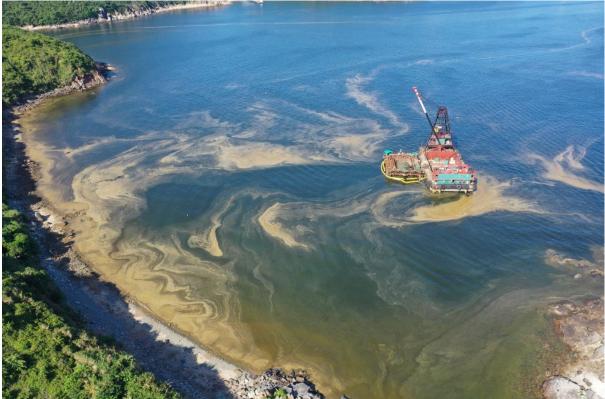
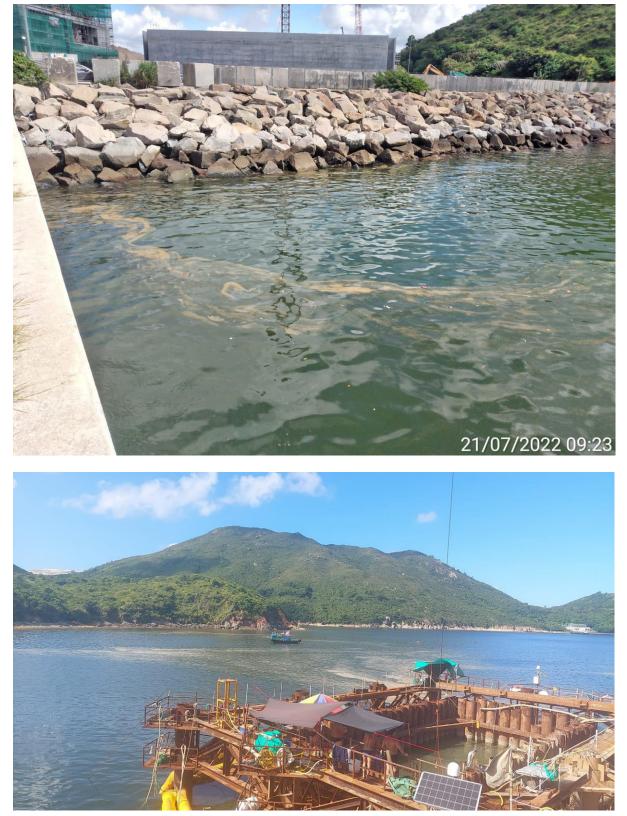
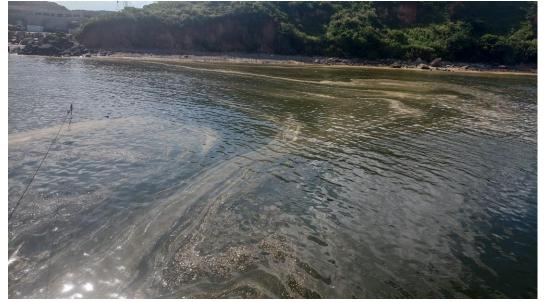
Red Tide on 21 July 2022:

- 3.24. Algal Bloom and red tide were observed at the marine water near CEDD pier and Intake Shaft on 21 July 2022 by the Contractor. According to Agriculture, Fisheries and Conservation Department (AFCD) previous red tide occurrences record, five red tides were spotted in Hong Kong including Tung Lung Chau fish culture zone and Junk Bay on 21 July 2022. ET will closely monitor the water quality and the implementation of water mitigation measure, to ensure no adverse impact to water quality and ecology.
